RE: St. Lucie Unit 2
Docket No. 50-389
NRC Order EA-03-009 – Reactor Vessel Head and
Vessel Head Penetration Nozzle Inspection Results SL2-15

**NRC Order EA-03-009: Reactor Pressure Vessel Head and Vessel Head
Penetration Nozzle Post Outage SL2-15 Inspection Results**

**St. Lucie Unit 2 January/February 2005 (SL2-15) Post Outage Reactor Vessel
Upper Head Inspection Results:**

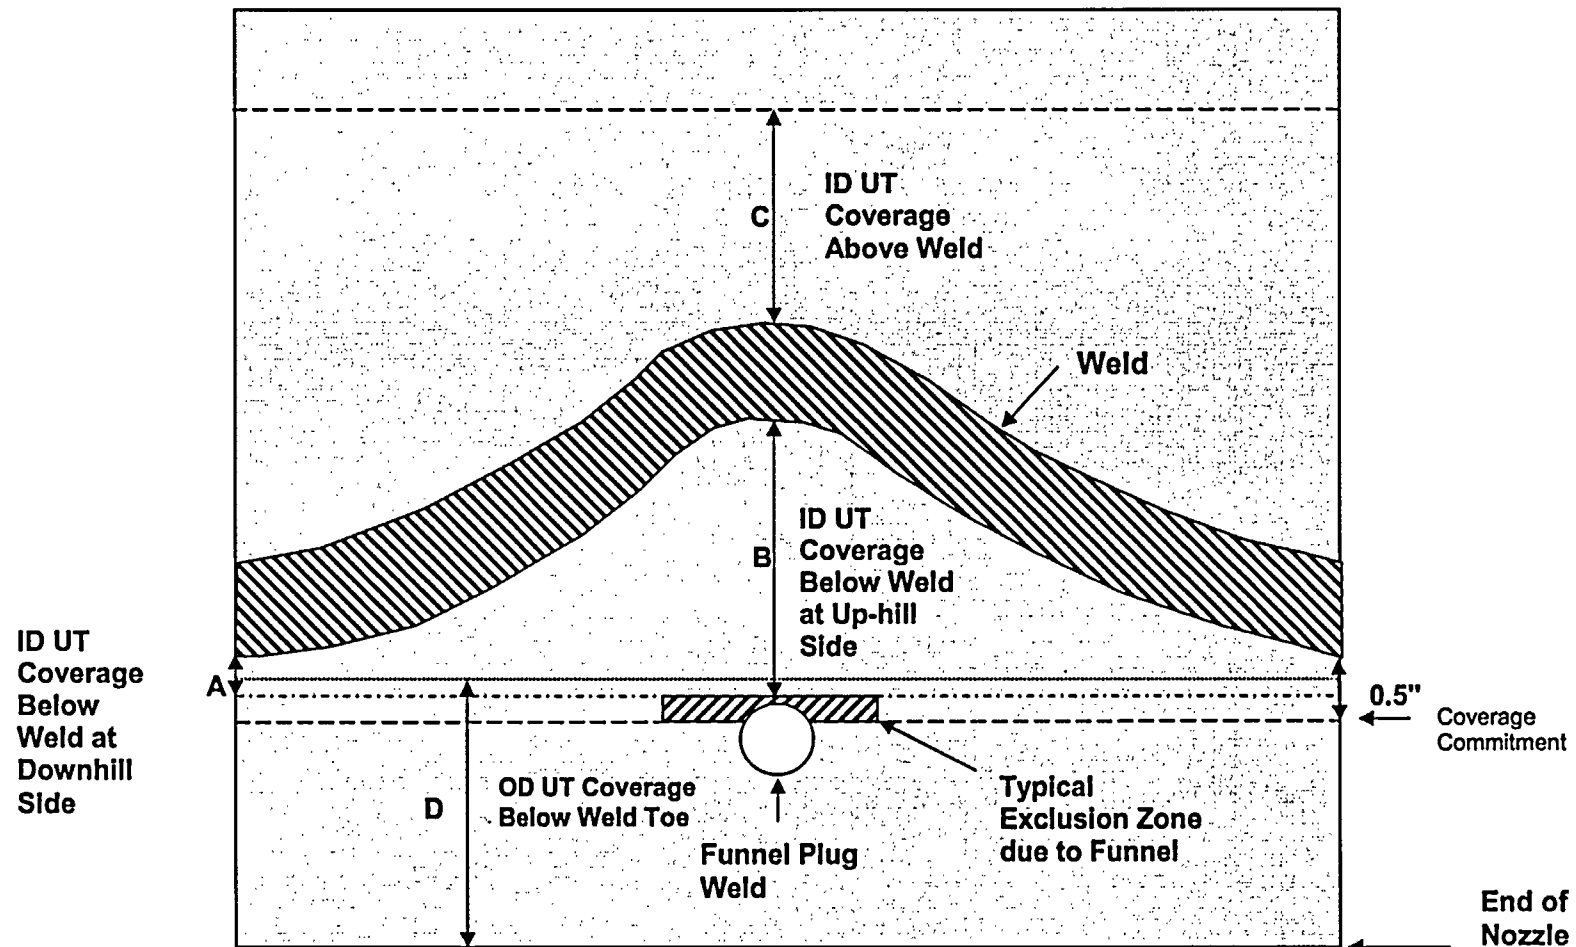
Figure 1: Sketch of St. Lucie Unit 2 Nozzle Coverage Limitations Below the Weld Toe and Funnel Plug Weld

Supplemental OD NDE was required on 17 CEDM nozzles to obtain the required examination area below the weld. The OD NDE method included UT and manual dye penetrant (PT). A limitation was experienced on 14 CEDM nozzles, where the OD UT was utilized to extend the coverage below the weld toe. These limitations were caused by lift off at the funnel plug weld on the high hillside of the nozzle. The small lift off limitations were ≥3.80 inches below the weld toe and are described in the attached coverage assessment table. This supplemental OD NDE did not reveal any relevant indications.

- 1) Nozzle 89 coverage is limited 360 degrees for the axial extent listed as 0.075" and also limited by the funnel weld plug for the dimensions listed.
- 2) The angular coordinate for the OD UT was established visually by placing the transducer at the uphill side and declaring that position 180 degrees.
- 3) Position accuracy is estimated to be ± 20 degrees.
- 4) Nozzles 54, 85, and 89 were supplemented by PT examination on the nozzle OD to provide coverage of a band extending 0.5" below the weld toe.
